TOLLYCRAFT YACHTS

TOLLYCRAFT SERVICE BULLETIN

ALL 30' TOLLYCRAFT SPORT CRUSIERS

Regarding: All 30' Sport Cruiser Tollycrafts, hull numbers 601-828.

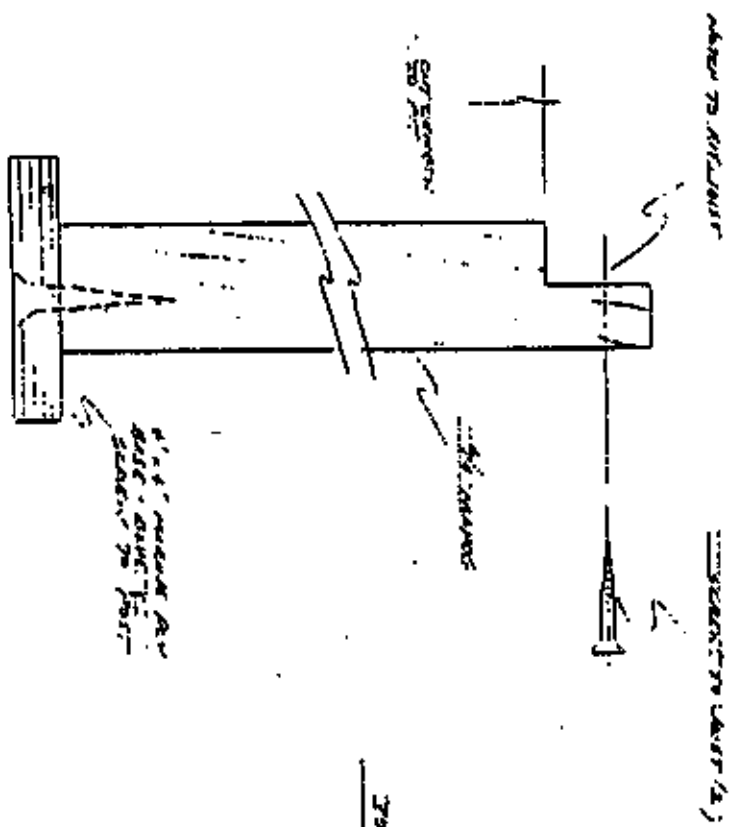
DRAWING #A

Some 30' Sport Cruiser owners have experienced separated or broken fiberglass tabs (fiberglass mat which bonds wood to the hull). We recommend you make the enclosed modifications to your boat.

Through bolt mahogany posts from the stringer to the floor joists (see drawing A). This can be done by removing the carpet, cutting the salon floor in way of the water tank (see drawing B), and the galley area under the refrigerator. In addition the inspection hatches need to be enlarged at; the salon entry, and the two outboard hatches forward of the shower and the galley (see drawing B).

The water tank should be removed, and the posts will be located under each floor joist and then bolt the posts in place to the inside longitudinal stringers, six per side (see drawing C).

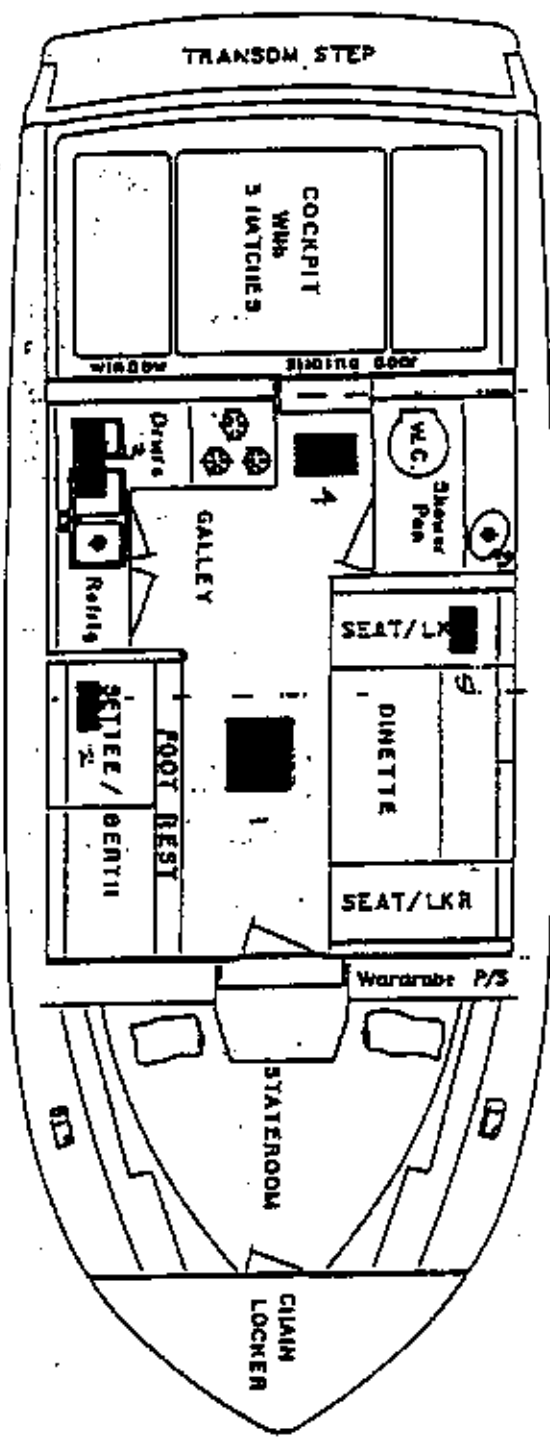
- Hatch #1 Look aft at fuel tank bhd along hull/bhd interface
- Hatch #2 Look at the fuel tank bhd itself for damage
- Hatch #3 Look at engine bhd at hull side
- Hatch #4 Look at the engine bhd along the hull/bhd interface
- Hatch #5 Look fwd at the fuel tank bhd along the hull side
